## WavTex™ – Before & After

### Chicken Processing Plant

A chicken processing plant's wastewater treatment lagoon during and after the installation of six floating WavTex modules is shown in the photos.

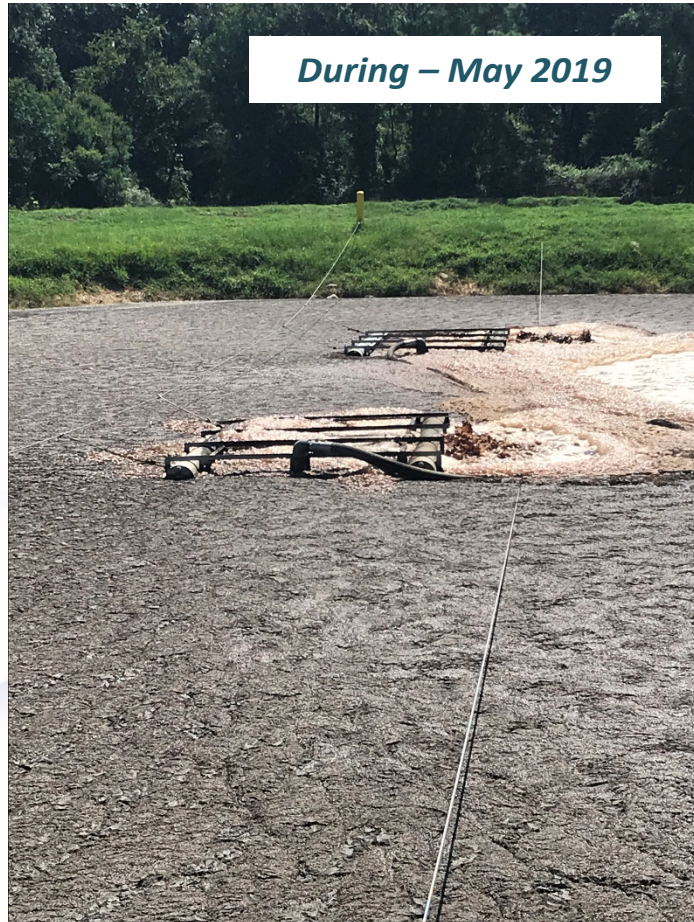
The existing floating aerators did not provide enough mixing or treatment capacity, resulting in the thick, crust in the photo and insufficient ammonia removal.

To prevent effluent ammonia surcharges, reduce odor, and alleviate the crust formation, six floating WavTex modules with EnTextile™ media sheets were installed in the lagoon in May 2019. They came complete with integrated coarse bubble aeration grids that are suspended from floats near the bottom of the lagoon, optimizing oxygen transfer and mixing. Further, the biology living on the high surface area EnTextile media sheets significantly increased the capacity for BOD and ammonia removal.

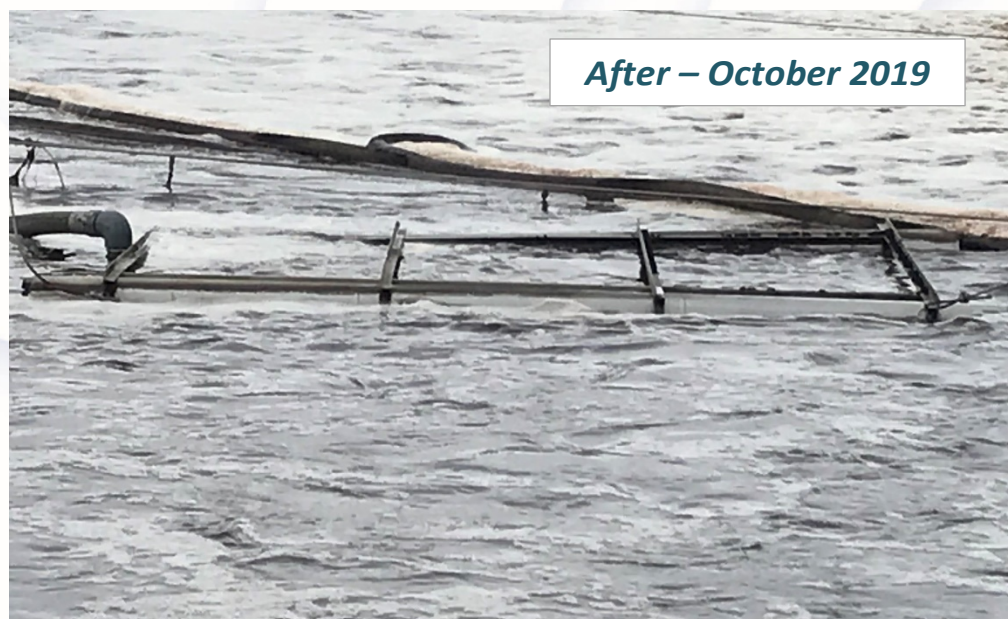
The WavTex modules have provided dramatic improvements. This can be seen visually by the absence of crust in the bottom right photo (taken just 6 months after the top photo)! These results are also evident numerically - last summer (their high season for production) was the first summer ever that they had no effluent ammonia surcharges. Odor near the lagoon has also been significantly reduced.
